ESKIMO VII TEST RESULTS

Robert N. Martha

Naval Civil Engineering Laboratory

ESKIMO VII, seventh in the series of Explosive Safety Knowledge Improve-
ment Operation Tests, was conducted to determine the safety and performance
of Navy box-shaped ammunition storage magazines. The two magazines tested,
the Type A (new design) and Type IIB (old design), were the remaining half-
scale structures from the July 1980 ESKIMO VI test. The Type A magazine was
tested using a foam High Explosive Simulation Technique (HEST) on its roof.
The Type IIB magazine was tested one week later using a small hemispherical
surface charge of 13,616 pounds of TNT. The two interior columns of the
Type A magazine catastrophically collapsed when subjected to a HEST impulse
approximately three times greater than the design impulse. Although the
yield-line pattern and response predicted for the flat-slab structure never
occurred, the roof remained intact while undergoing maximum support rotations
of 16 degrees. These data indicate a high probability of eliminating the

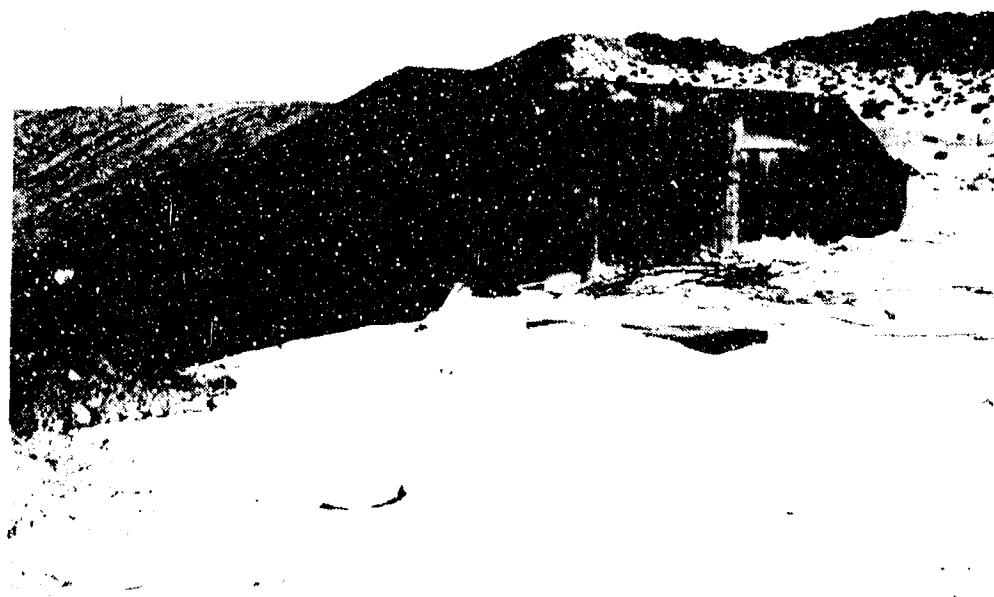
Figure 2. Exterior view of Type A magazine before test.

In ESKIMO VI the roof parapet (a low wall used to retain the 1-foot soil cover on the roof) was severely damaged. The parapet was refurbished and increased in height from 1 foot 5 inches to a total height of 2 feet 9 inches. This modification was needed to retain the additional 12 inches of uncompacted native soil overburden required above the foam HEST cavity. The steel wing walls in the region adjacent to the structure were also increased in height (see Figure 2).

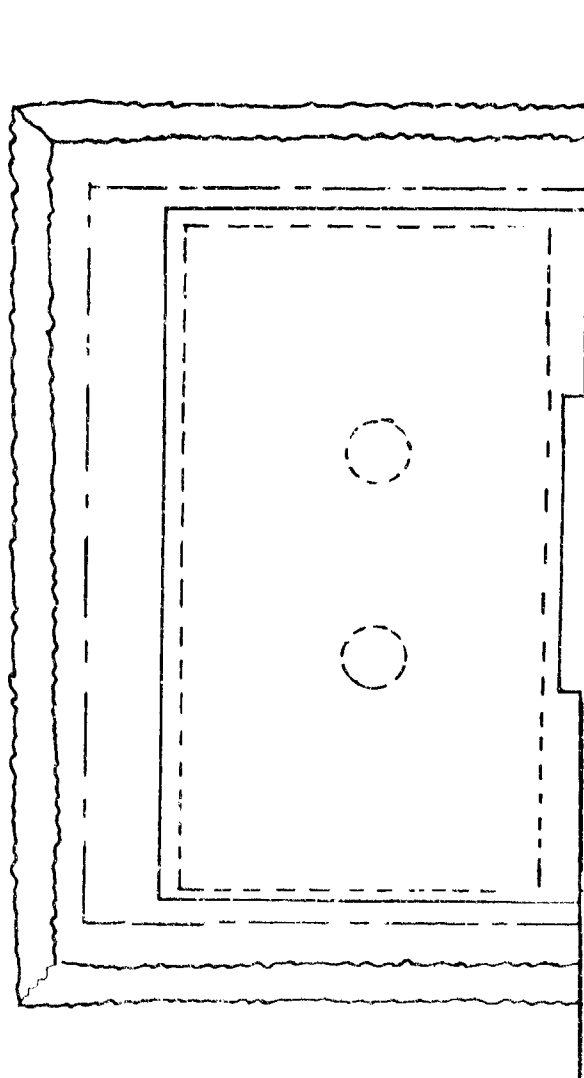
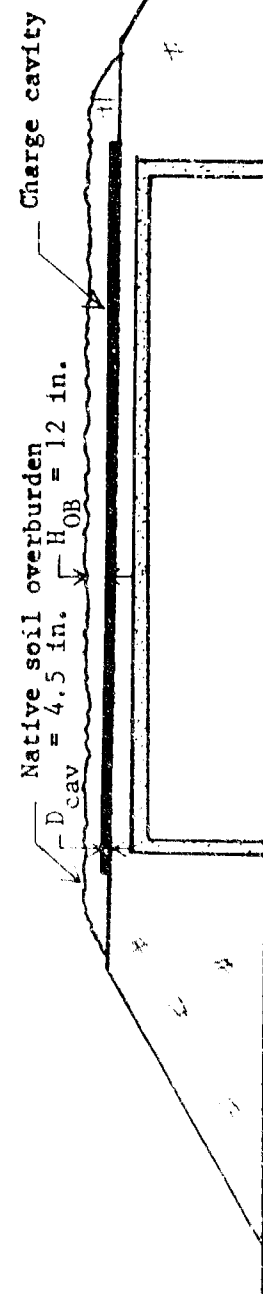
(a) Plan view

Section through mid-band

Figure 3. Foam HEST configuration and placement.

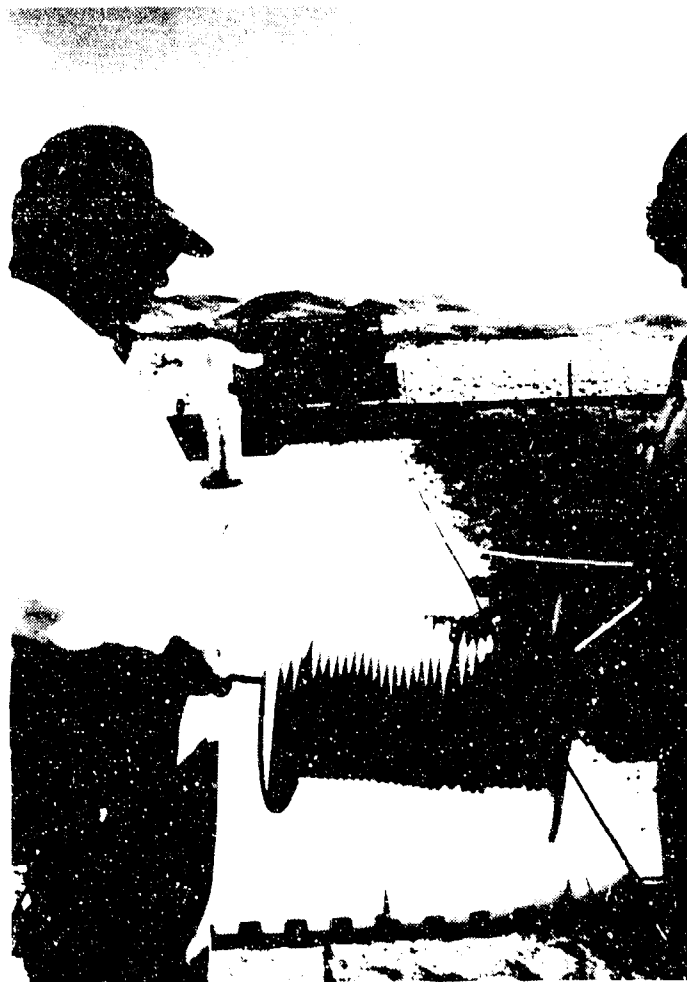
Figure 5. Construction of foam HEST charge cavity above Type A magazine root.

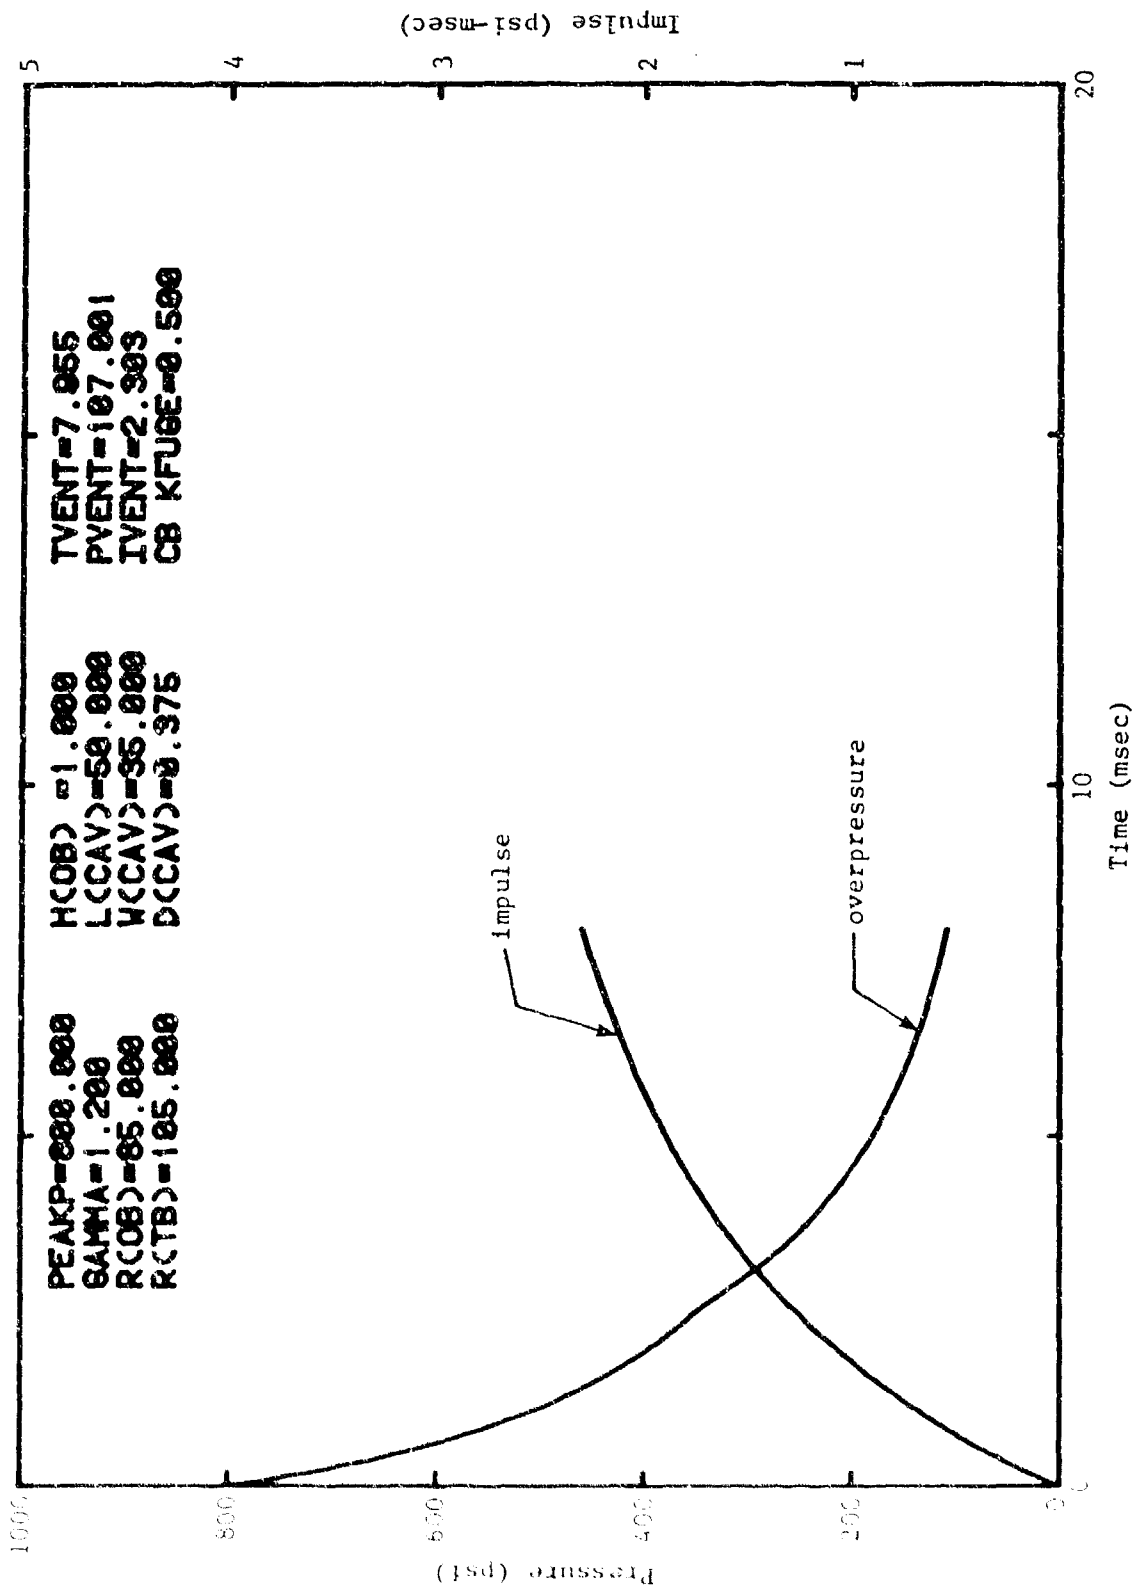
Figure 6. HEST design code output for foam HEST A-ROOF parameters.

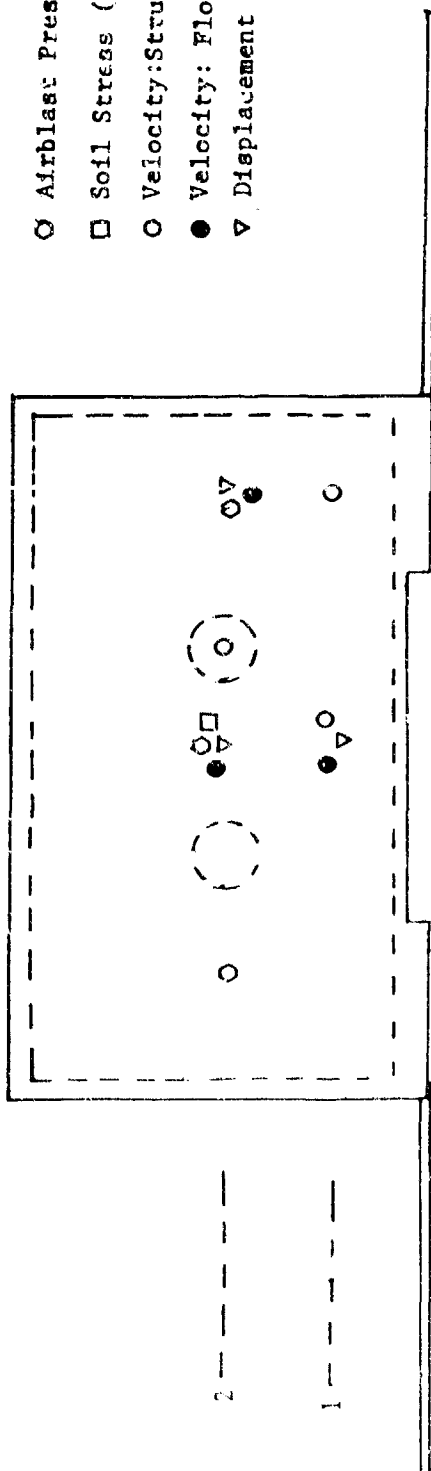
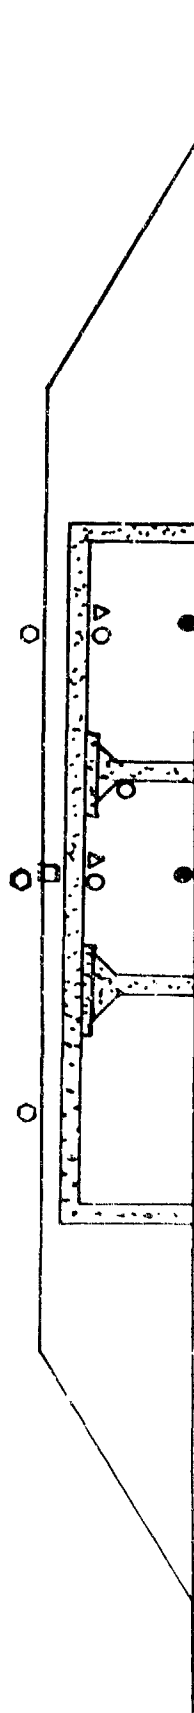
Figure 7. Type A magazine gauge locations for Test A-ROOF.

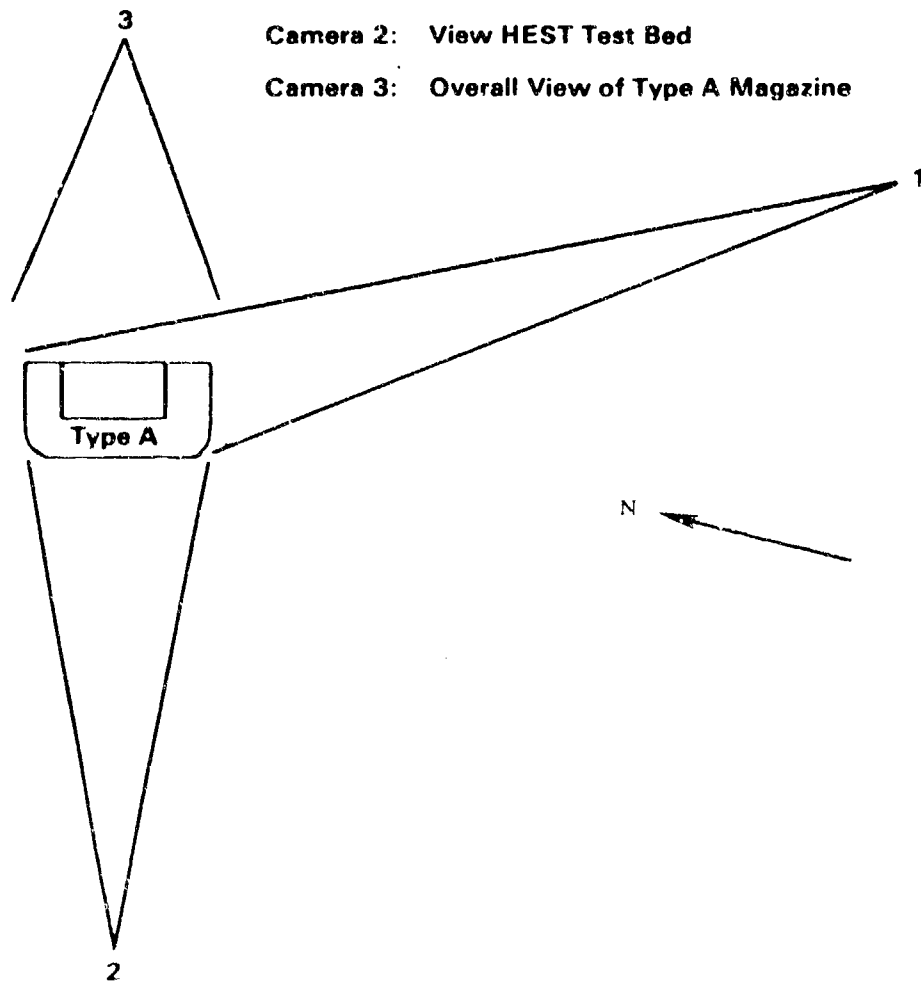
Figure 8. Test A-ROOF camera locations and field-of-view definition.

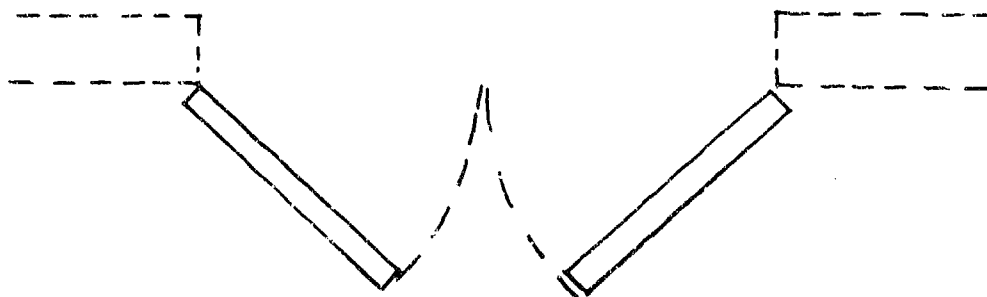
(a) ESKIMO VI: Double leaf/hinged

(b) ESKIMO VII: Single leaf/sliding

Figure 9. Type IIB magazine door.

The performance of the Type IIB test structure in ESKIMO VI showed that the current double-leaf hinged door design was inadequate for resisting the blast loads. These doors were forced inward, bending past the door stops, and were separated from their hinges, coming to rest in the corresponding rear corners of the magazine. A redesign of the door/ headwall was undertaken in connection with ESKIMO VII. In addition to satisfying explosives safety criteria, the new door design also satisfies physical security criteria for theft (Ref 8). The new door configuration shown in Figure 9 is similar to the sliding single-leaf system of the Type A magazine. The construction drawings for the half-scale components to be tested are shown in Figures 10 and 11. Construction photographs of the modifications are shown in Figures 12 and 13.

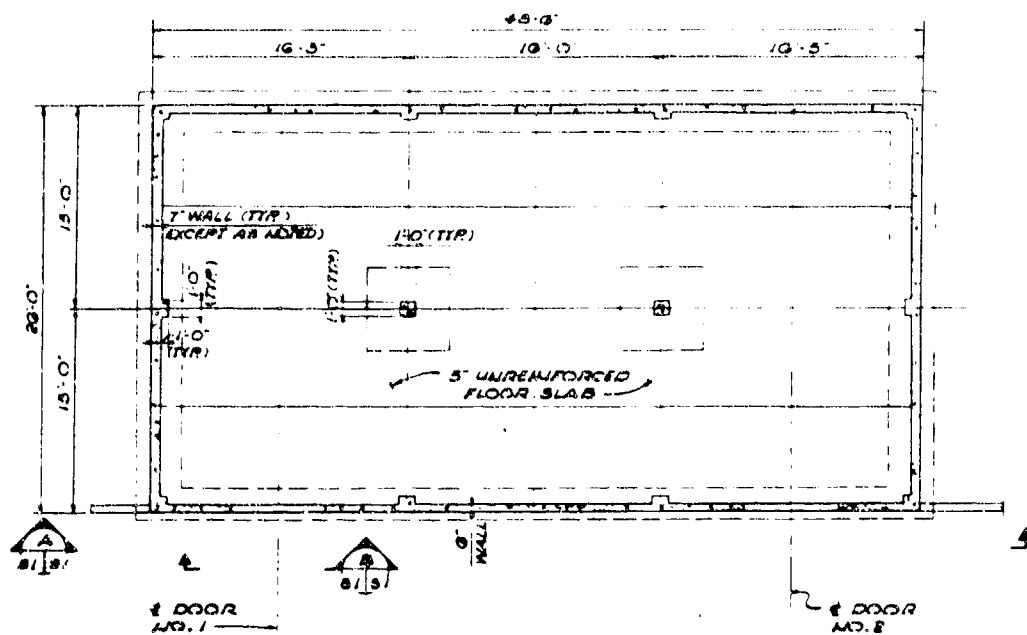
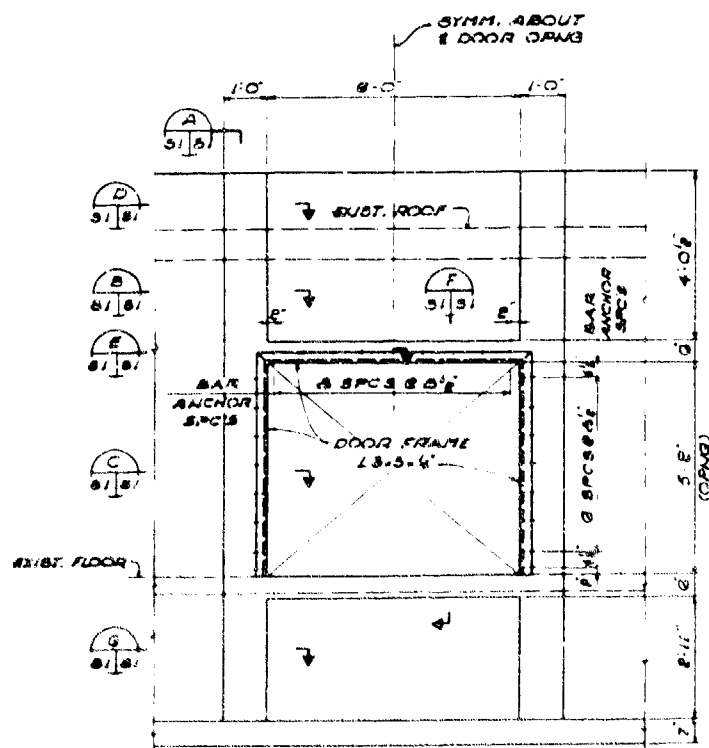
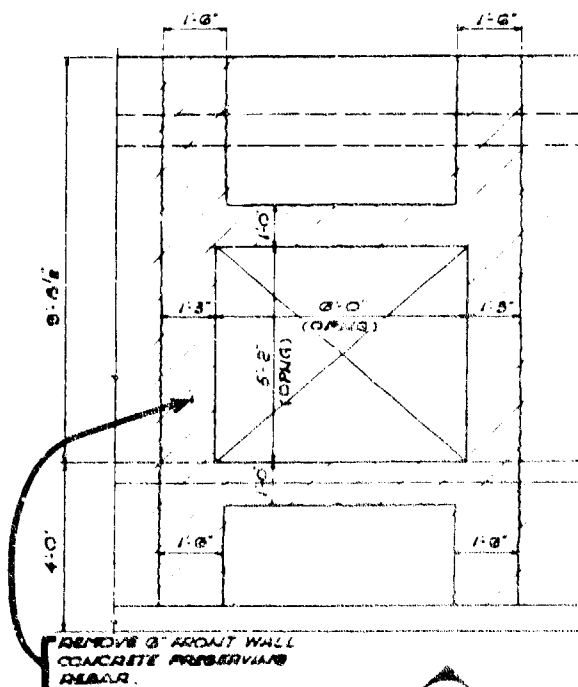
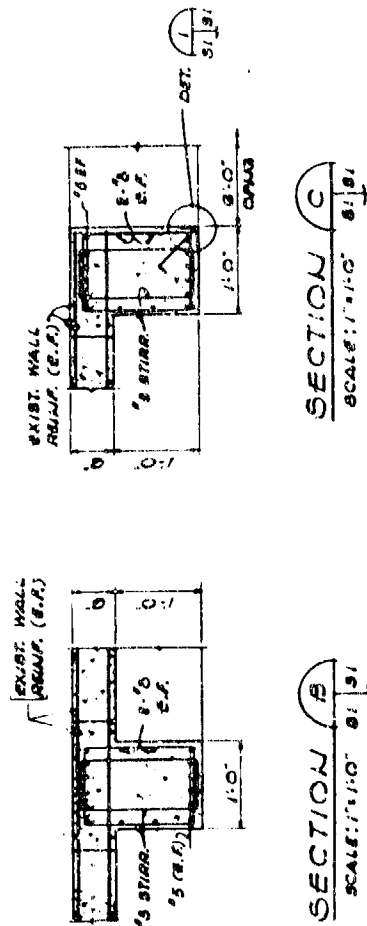
MODIFIED DOOR

DEMOLITION

Figure 10. Construction drawing of half-scale Type IIB magazine headwall modifications.

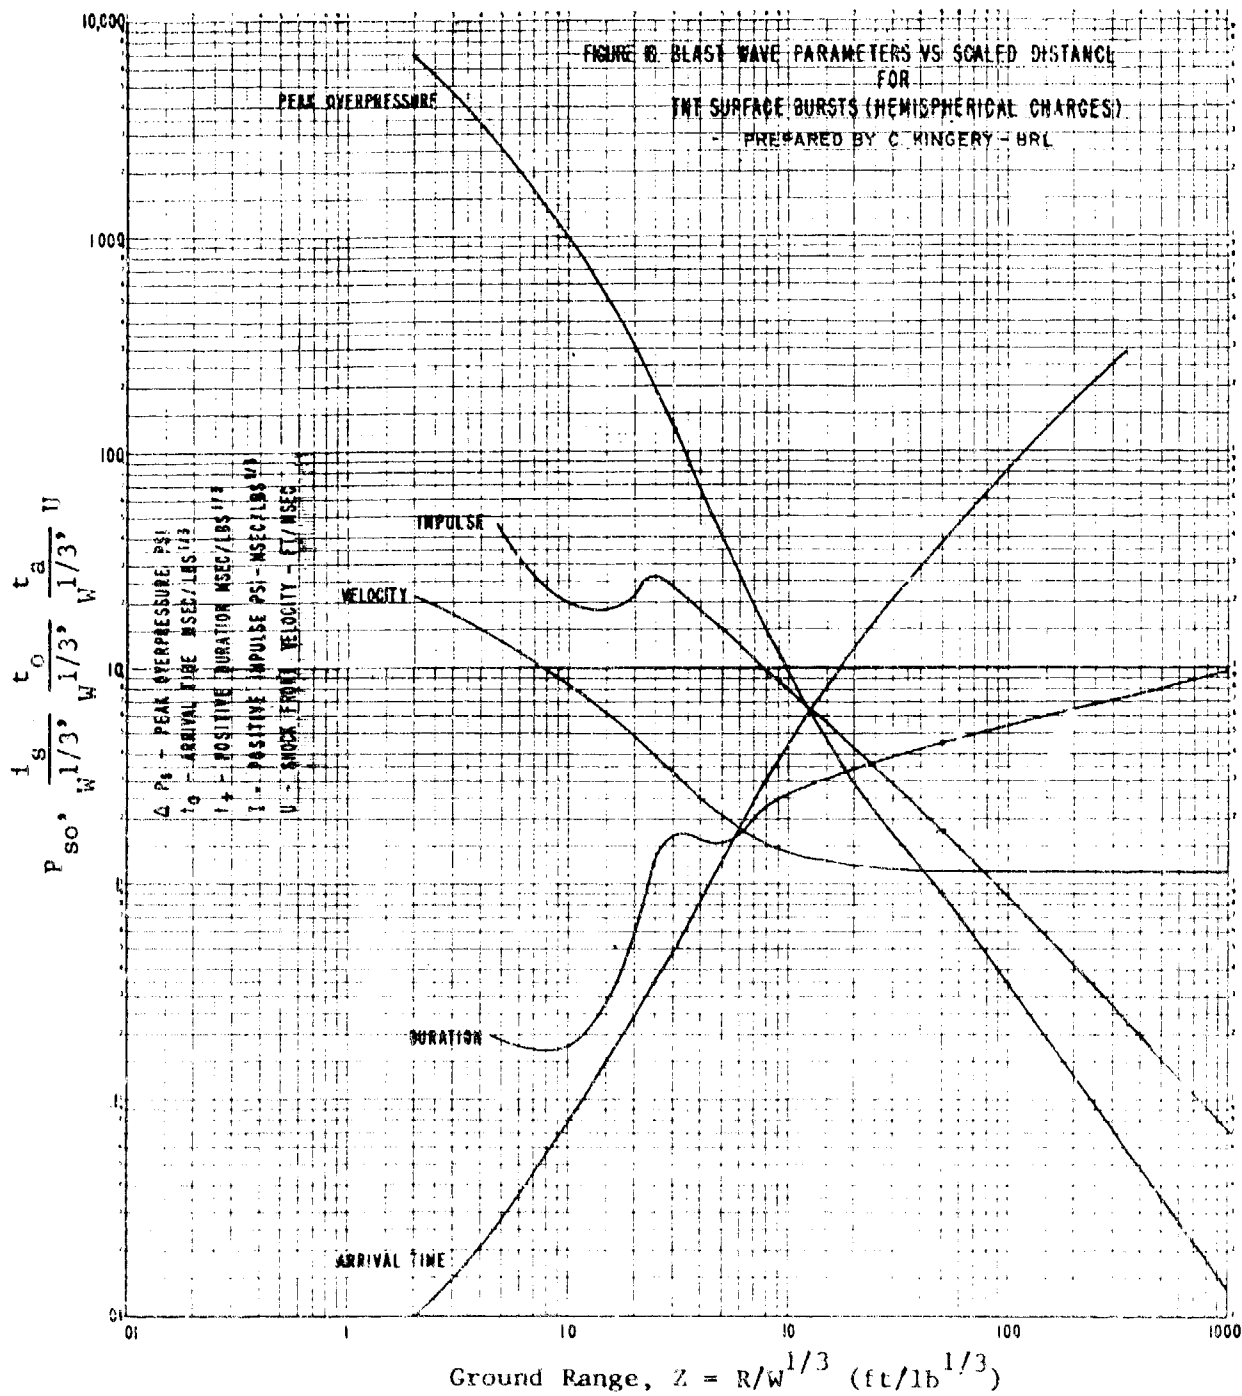
Figure 14. Blast wave parameters versus scaled distance for hemispherical TNT surface bursts (Ref 9).

^cFrom Figure 14

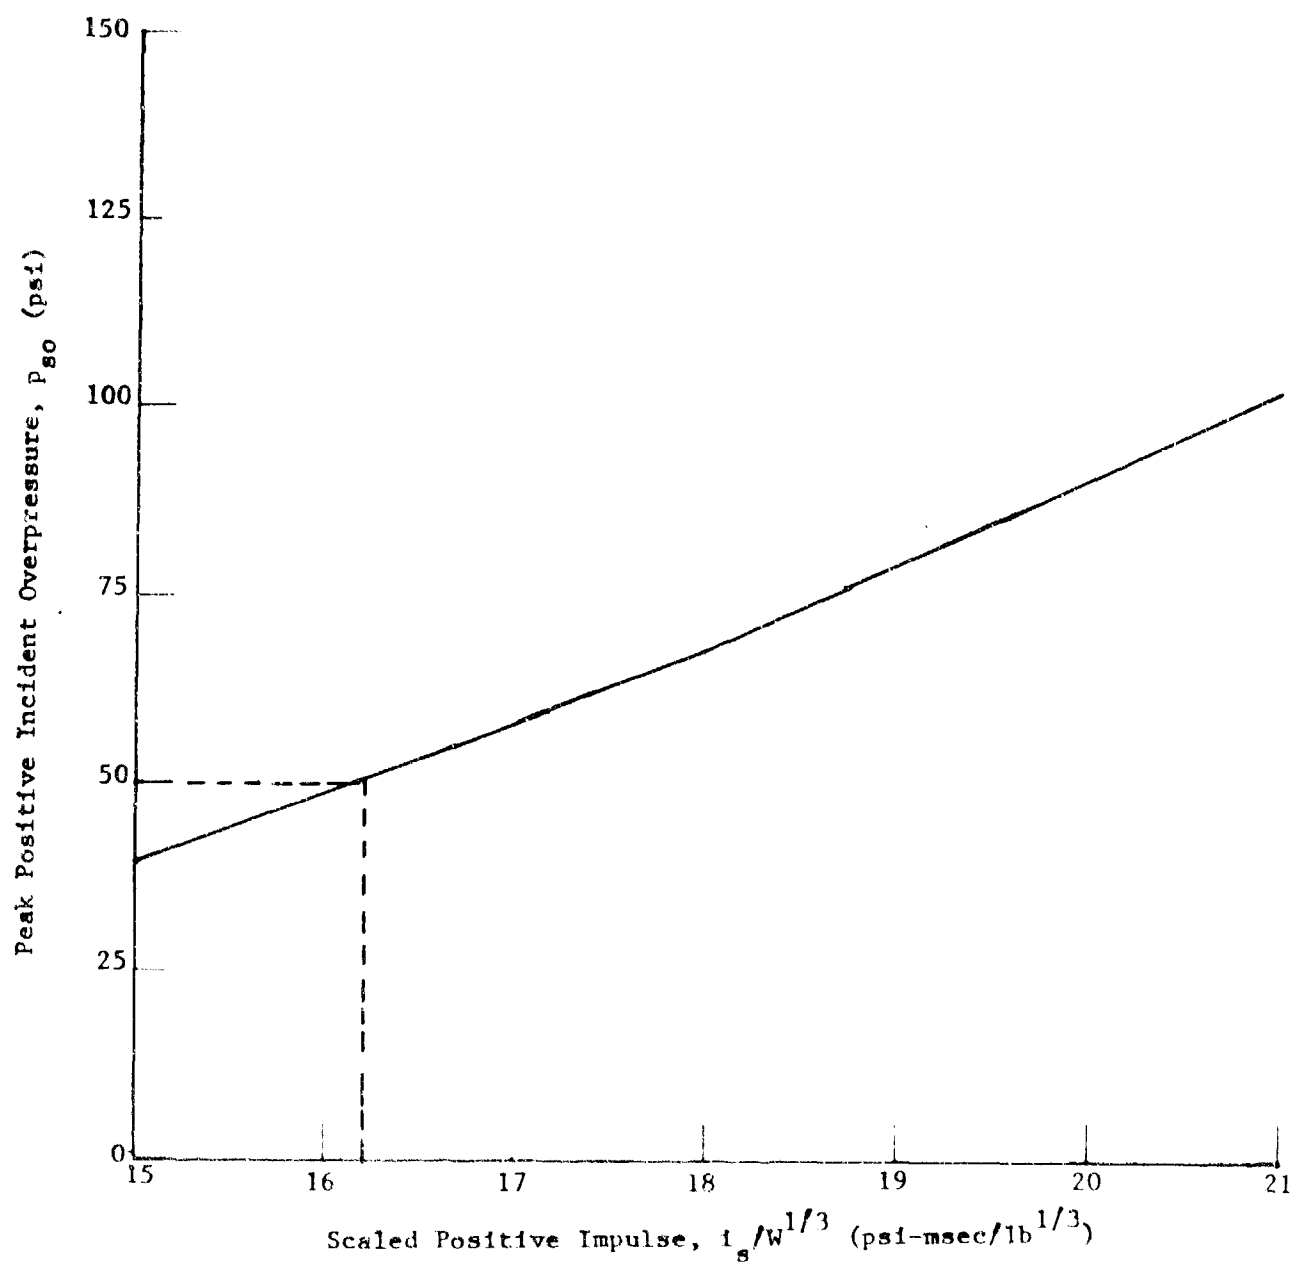
Figure 15. Peak positive incident overpressure versus scaled unit positive incident impulse for hemispherical charge (Ref. 9)

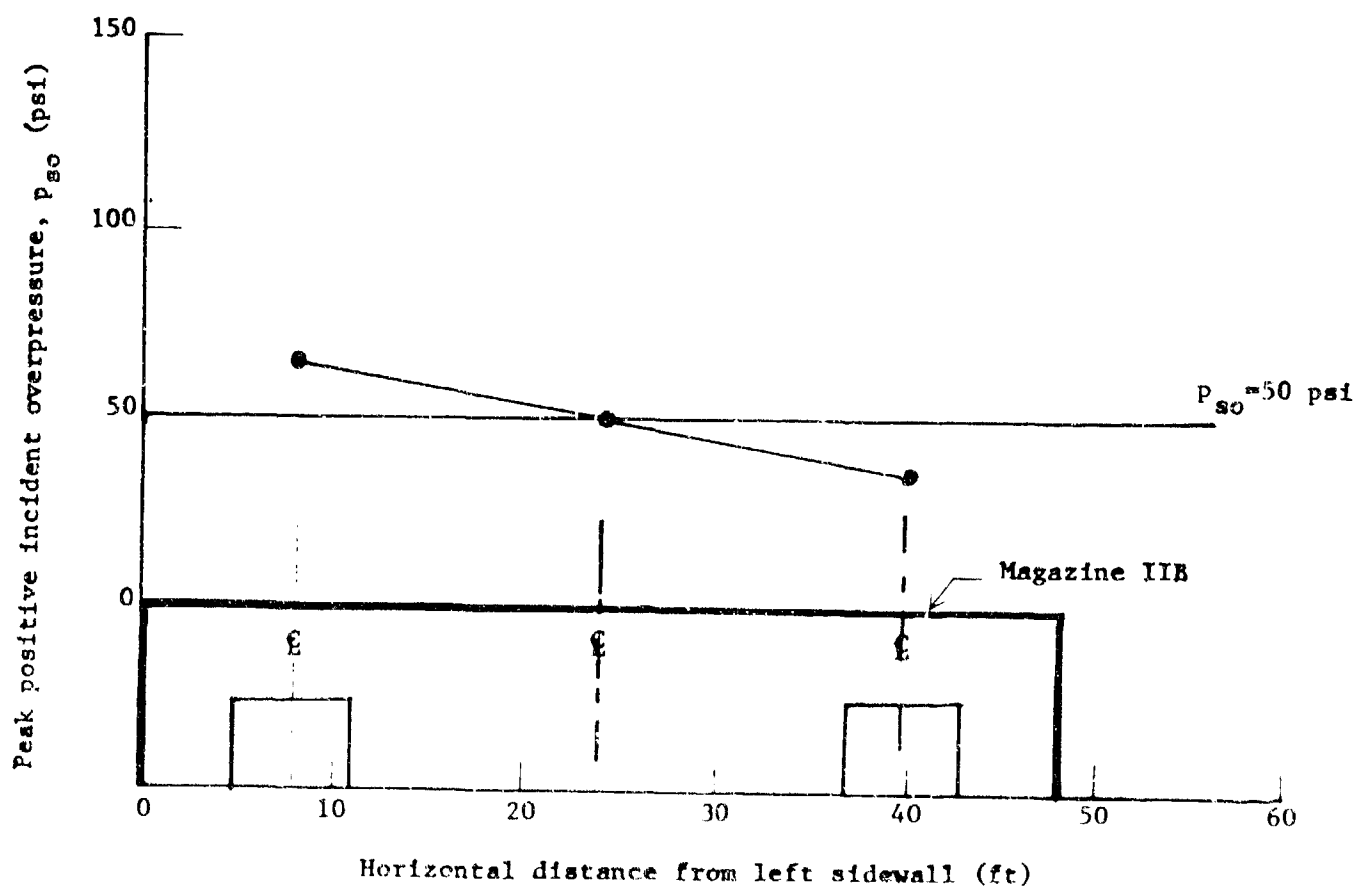
Figure 16. Peak positive overpressure acting along Type IIB magazine; $W = 13,616$ lb.

The values at both door centerlines were also calculated and are listed in Table 2 and shown in Figures 16 and 17.

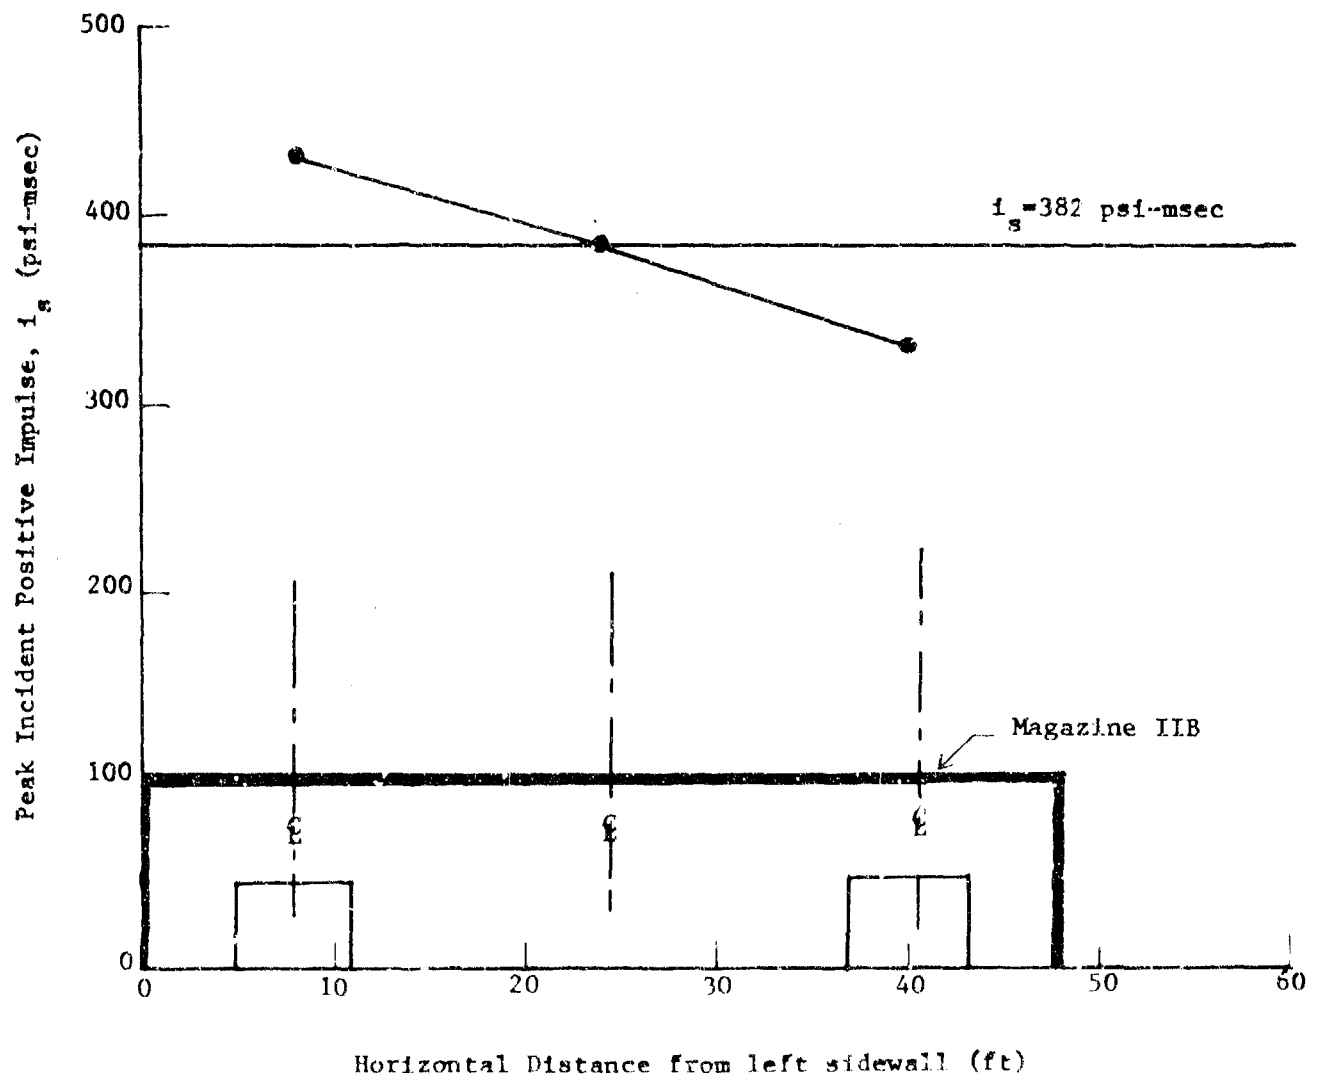
Figure 17. Impulse acting along Type IIB magazine; $W = 13,616$ lb.

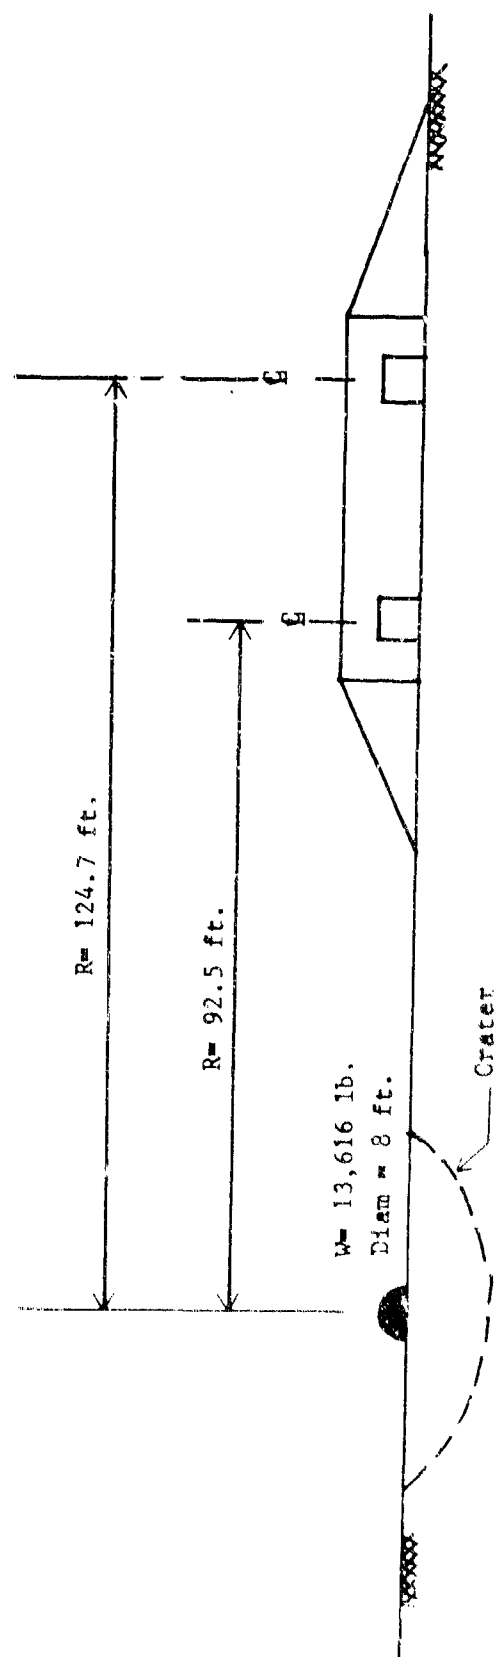
Figure 18. Test i1B-DOORS layout configuration.

The calculated crater radius for a 13,615-pound charge is 24.6 feet. As shown in the proposed test configuration of Figure 18, cratering is of no concern.

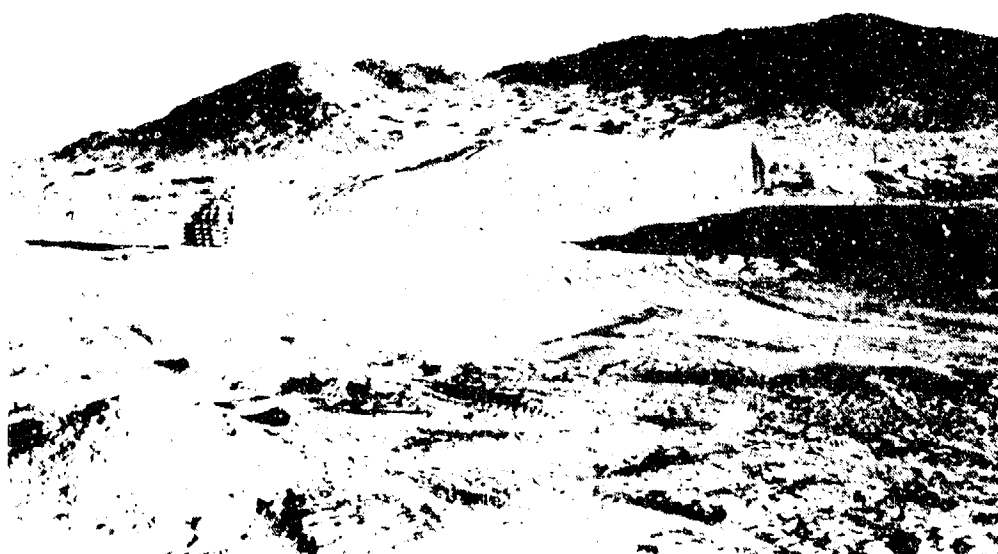
Figure 19. Type HB test structure and hemispherical surface charge.

The charge was constructed of 8-pound TNT blocks (2 by 6 by 12 inches) and is shown in Figure 19.

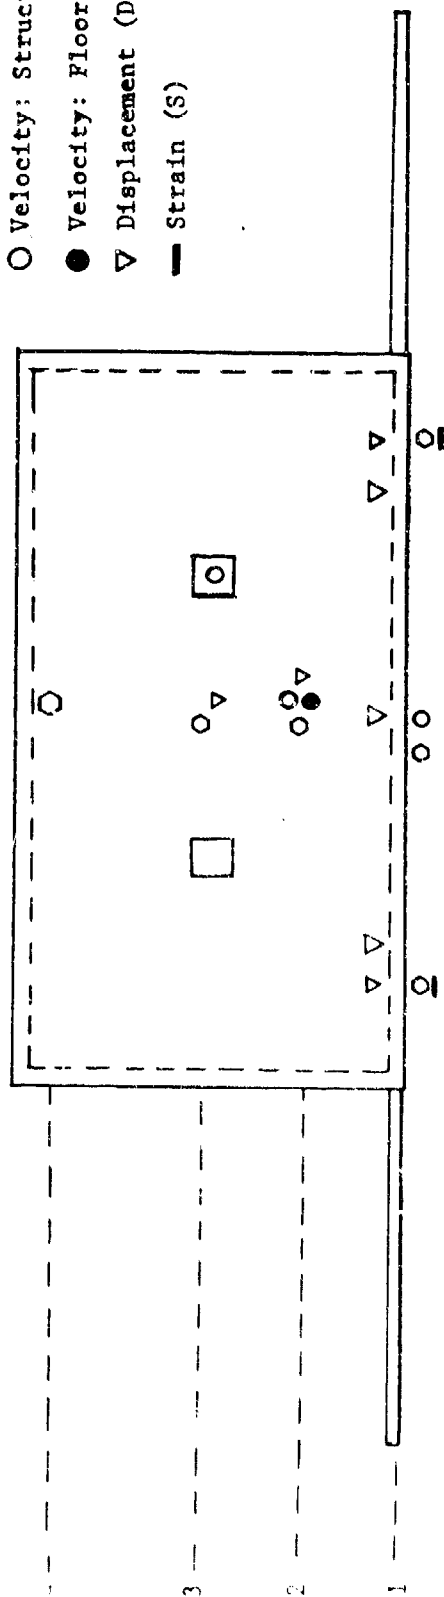
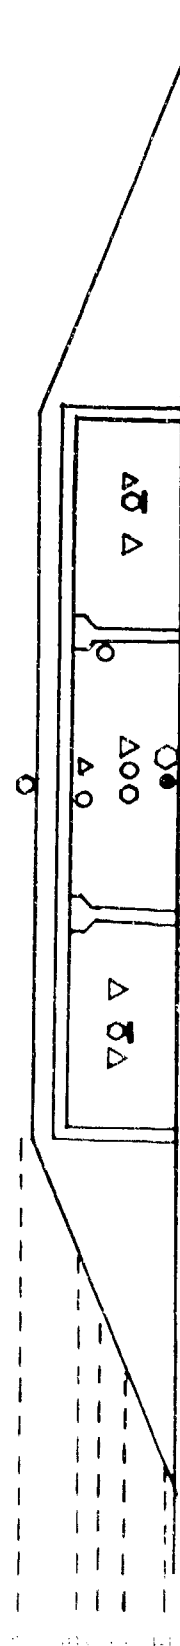
Figure 20. Type IIB magazine gauge locations for Test IIB-DOORS.

Figure 20 is a schematic of the active instrumentation recording the blast environment at the Type IIB magazine. Surface airblast pressure gauges located along gage lines at 90 and 180 degrees recorded the free-field pressure-time environment (Figure 21, Table 3). These gauges were installed in heavy-gage mounts to read the side-on pressure loads. A detailed description and purpose for each gauge is listed in Table 4. A total of 31 gauges were used.

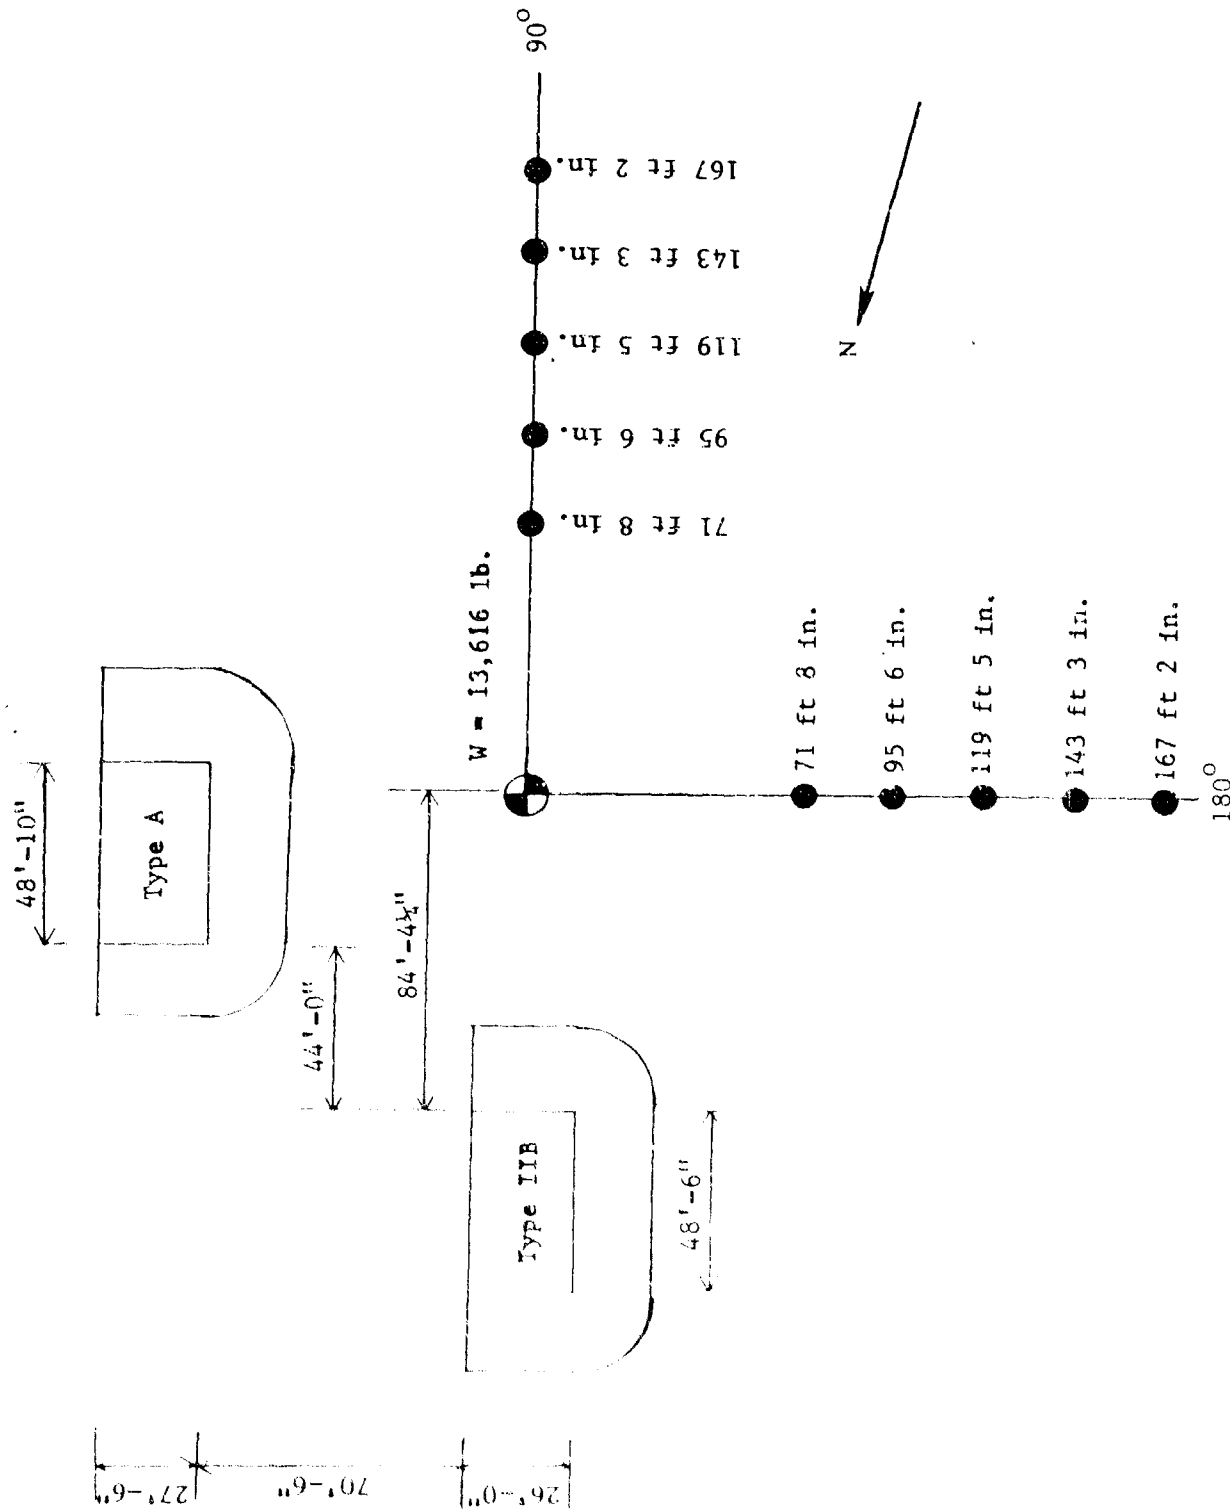
Figure 21. Free-field pressure gauge locations for Test IIB-DOORS.

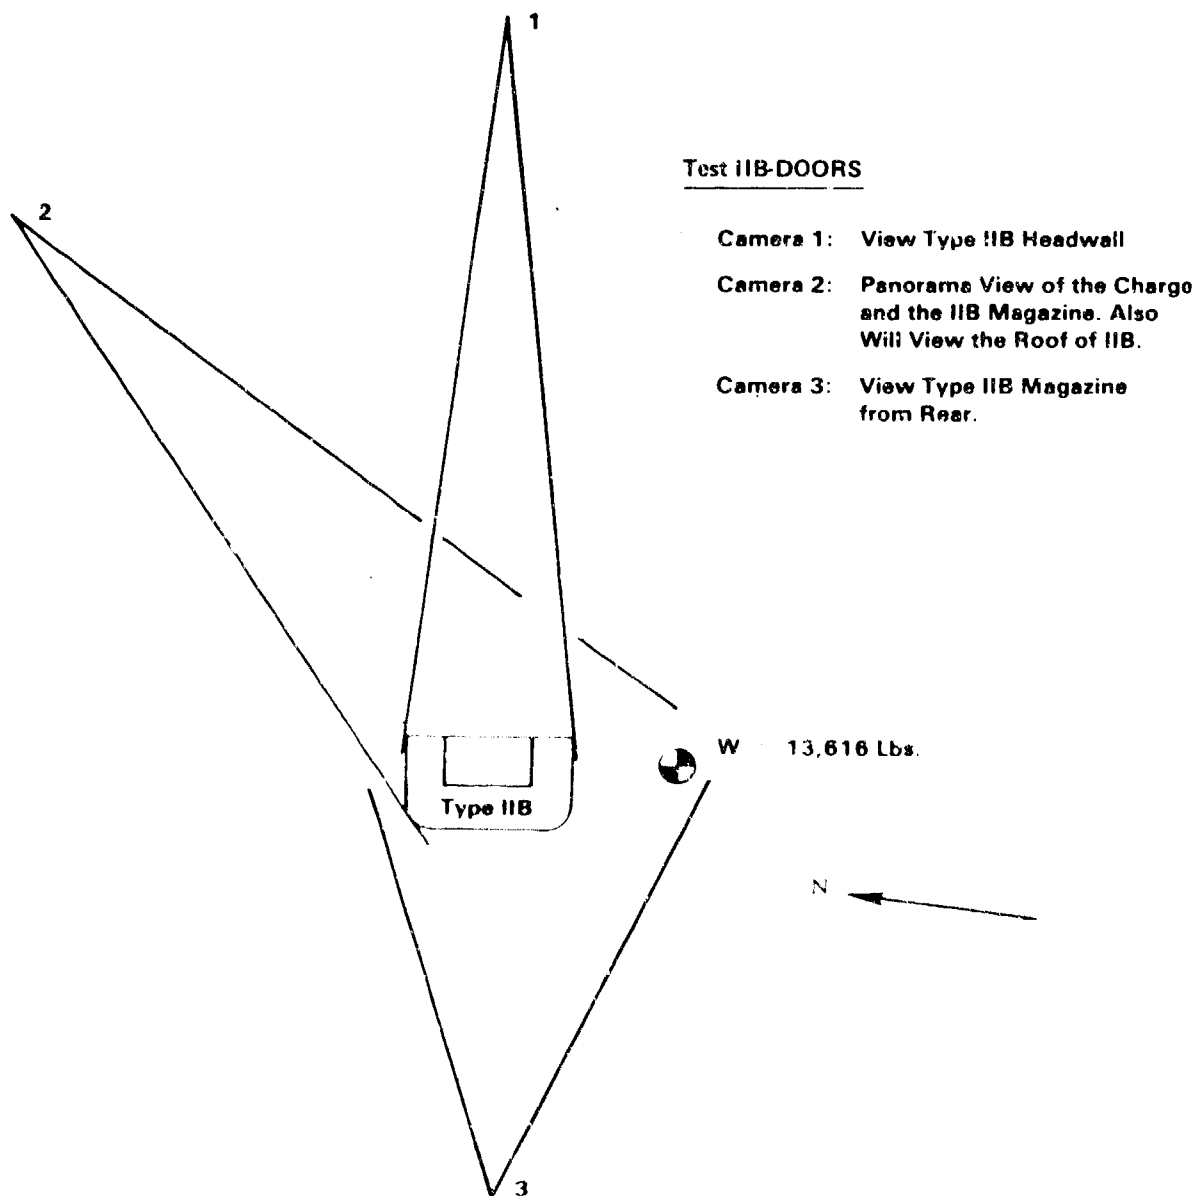
Figure 22. Test IIB-DOORS camera locations and field-of-view definition.

The test was recorded photographically by ground and air-based 16mm cameras using color film at speeds ranging from 24 frames/second to 10,000 frames/second. Figure 22 illustrates the locations of the ground cameras.
